Annual Playground Inspection for Gouldburn Green Play Area, The Street, Betchworth RH3 7DH

Inspection date and finish time	08/11/2022	11.10	Report date	11/11/2022
---------------------------------	------------	-------	-------------	------------

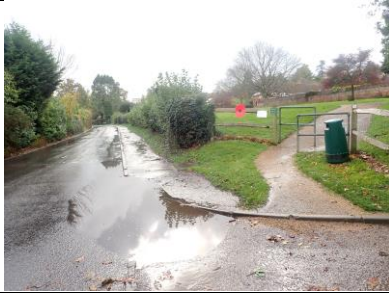
Faults or failures see below	
Hazard Road	The site is adjacent to a busy road and has a staggered barrier gate system. Children may stray into the road if parents were distracted

2 x 4 low	Consider alternative gate method to eliminate the hazard. Warning signs for approaching drivers further control measures
Hazard Tree	The site is dominated by a large tree. Trees do not form part of this inspection.

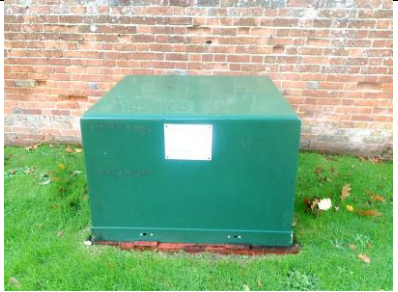
<p>Hazard Gas cabinet</p>	<p>There is a Southern Gas network installation, the cover is easily lifted. Utility installations do not fall under the scope of this inspection. A sign has been placed on the item but consider more control measures</p>

<p>No risk value could be given</p>	<p>Contact the owner and request the cabinet is secured or seek assurances of the suitability of the siting</p>
<p>SITE: Gates, fence, signs, seats, bins</p>			<p>RISK ASSESSMENT & ACTION IF NECESSARY</p>	
<p>ASSESSMENT</p>			<p>Risk Assessment</p>	<p>Action</p>
<p>Equipment: Fence</p> <p>Location: Perimeter of the area</p> <p>Manufacturer: No manufacturer identified</p> <p>Material: Timber, metal infill</p>

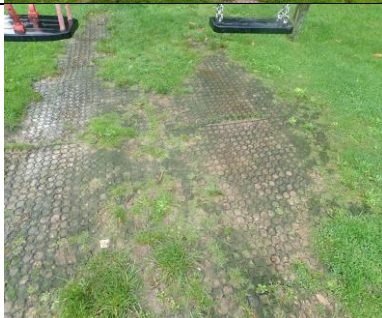
Faults or failures see below		
<p>Hazard Impact absorbent surface</p>	<p>It is important to note that the critical fall height (CFH) and head impact criteria (HIC) may differ due to change of soil conditions, weather, and local factors. It was not possible to test the grass matrix tiles on site, due to these factors. It is important to maintain good soil conditions to ensure the CFH is maintained.</p>

<p>2 x 4 Low</p>	<p>The surface should be routinely inspected, rubbish or debris removed. Check for compaction and consult the manufacturer/supplier for further advice on how to rectify.</p>
