TMPI LTD

Annual Playground Inspection for Gouldburn Green Play Area, The Street, Betchworth RH3 7DH

Inspection date and finish time	09/11/2023	09.30	Report date	11/11/2023
 				<p>Overall area risk level:</p> <p>LOW</p>

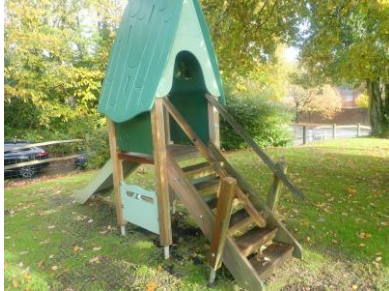
SITE: General surfacing, pathways		RISK ASSESSMENT & ACTION IF NECESSARY	
ASSESSMENT		Risk Assessment	Action
Approaches The site is located in a partially walled garden, it is adjacent to a road and partially overlooked by houses

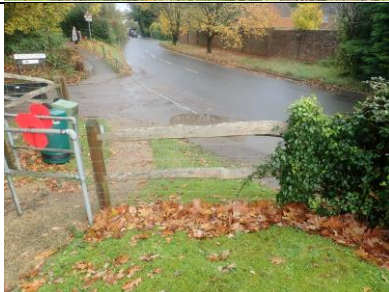
Faults or failures see below	
Hazard Road	The site is adjacent to a busy road and has a staggered barrier gate system. Children may stray into the road if parents were distracted

2 x 4 low	Consider alternative gate method to eliminate the hazard. Warning signs for approaching drivers further control measures
Hazard Tree	The site is dominated by several large trees. Trees do not form part of this inspection.

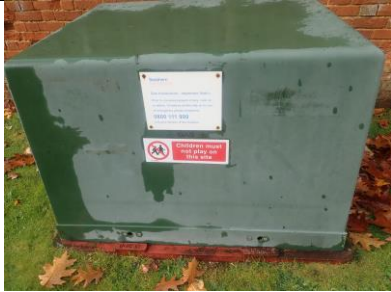
<p>Hazard Gas cabinet</p>	<p>There is a Southern Gas network installation, the cover is easily lifted. Utility installations do not fall under the scope of this inspection. A keep away sign has been placed on the item but consider more control measures</p>

<p>No risk value could be given</p>	<p>Contact the owner and request the cabinet is secured or seek assurances of the suitability of the siting</p>
<p>SITE: Gates, fence, signs, seats, bins</p>			<p>RISK ASSESSMENT & ACTION IF NECESSARY</p>	
<p>ASSESSMENT</p>			<p>Risk Assessment</p>	<p>Action</p>
<p>Equipment: Fence Location: Perimeter of the area Manufacturer: No manufacturer identified Material: Timber, metal infill</p>

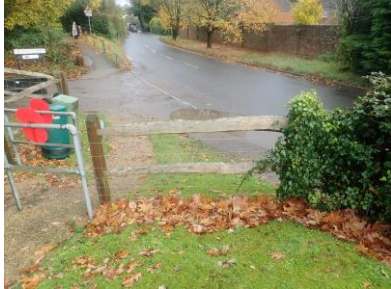
<p>No faults or failures found</p>		
<p>ASSESSMENT</p>			<p>Risk Assessment</p>	<p>Action required</p>
<p>Equipment: Bin Location: Entrance Manufacturer: No manufacturer identified Material: Plastic</p>

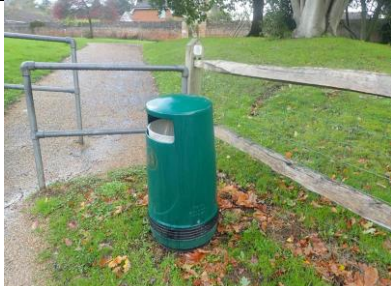
<p>No faults or failures found</p>
