Annual Playground Inspection for Gouldburn Green Play Area, The Street, Betchworth RH3 7DH

Inspection date and finish time	08/11/2022	11.10	Report date	11/11/2022
---------------------------------	------------	-------	-------------	------------

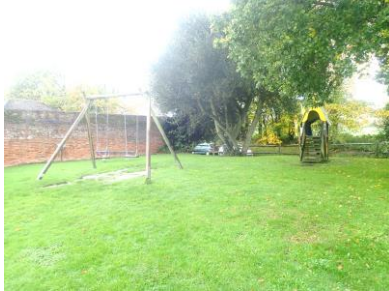
SITE: General surfacing, pathways		RISK ASSESSMENT & ACTION IF NECESSARY	
ASSESSMENT		Risk Assessment	Action
Approaches The site is located in a partially walled garden, it is adjacent to a road and partially overlooked by houses

Faults or failures see below	
Hazard Road	The site is adjacent to a busy road and has a staggered barrier gate system. Children may stray into the road if parents were distracted

2 x 4 low	Consider alternative gate method to eliminate the hazard. Warning signs for approaching drivers further control measures
Hazard Tree	The site is dominated by a large tree. Trees do not form part of this inspection.

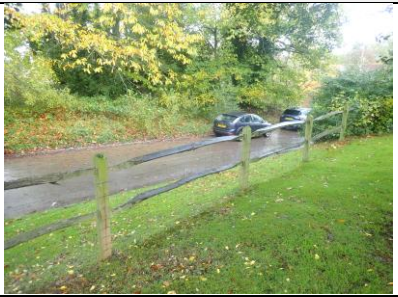
<p>No risk value could be given</p>	<p>Contact the owner and request the cabinet is secured or seek assurances of the suitability of the siting</p>
<p>SITE: Gates, fence, signs, seats, bins</p>			<p>RISK ASSESSMENT & ACTION IF NECESSARY</p>	
<p>ASSESSMENT</p>			<p>Risk Assessment</p>	<p>Action</p>
<p>Equipment: Fence</p> <p>Location: Perimeter of the area</p> <p>Manufacturer: No manufacturer identified</p> <p>Material: Timber, metal infill</p>

<p>No faults or failures found</p>		
<p>ASSESSMENT</p>			<p>Risk Assessment</p>	<p>Action required</p>
<p>Equipment: Bin</p> <p>Location: Entrance</p> <p>Manufacturer: No manufacturer identified</p> <p>Material: Plastic</p>

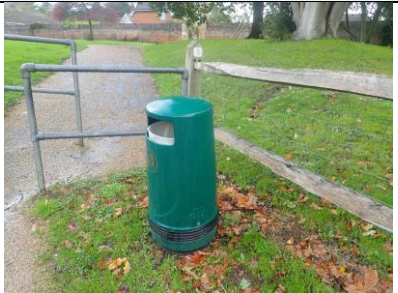
<p>No faults or failures found</p>

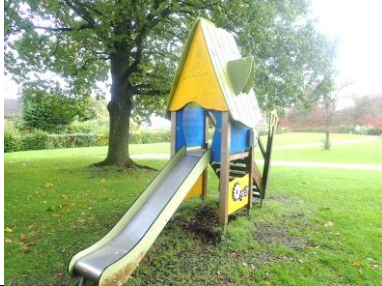
EQUIPMENT: Multi play, swings		RISK ASSESSMENT & ACTION IF NECESSARY		
ASSESSMENT		Risk Assessment	Action	
<p>Equipment: Multi play</p> <p>Manufacturer: Eibe play</p> <p>Surface: Grass matrix tiles</p>

No faults or failures found		
ASSESSMENT		Risk Assessment	Action	
<p>Equipment: 1 bay, mixed swings</p> <p>Manufacturer: Eibe play</p> <p>Surface: Grass matrix tiles</p>

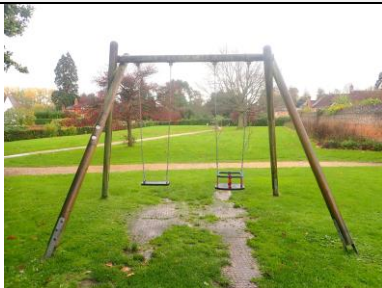
Faults or failures see below		
<p>Hazard Impact absorbent surface</p>	<p>It is important to note that the critical fall height (CFH) and head impact criteria (HIC) may differ due to change of soil conditions, weather, and local factors. It was not possible to test the grass matrix tiles on site, due to these factors. It is important to maintain good soil conditions to ensure the CFH is maintained.</p>
