The Street – Suggested
Road Safety
Improvements

The Problem

Suggested Improvements

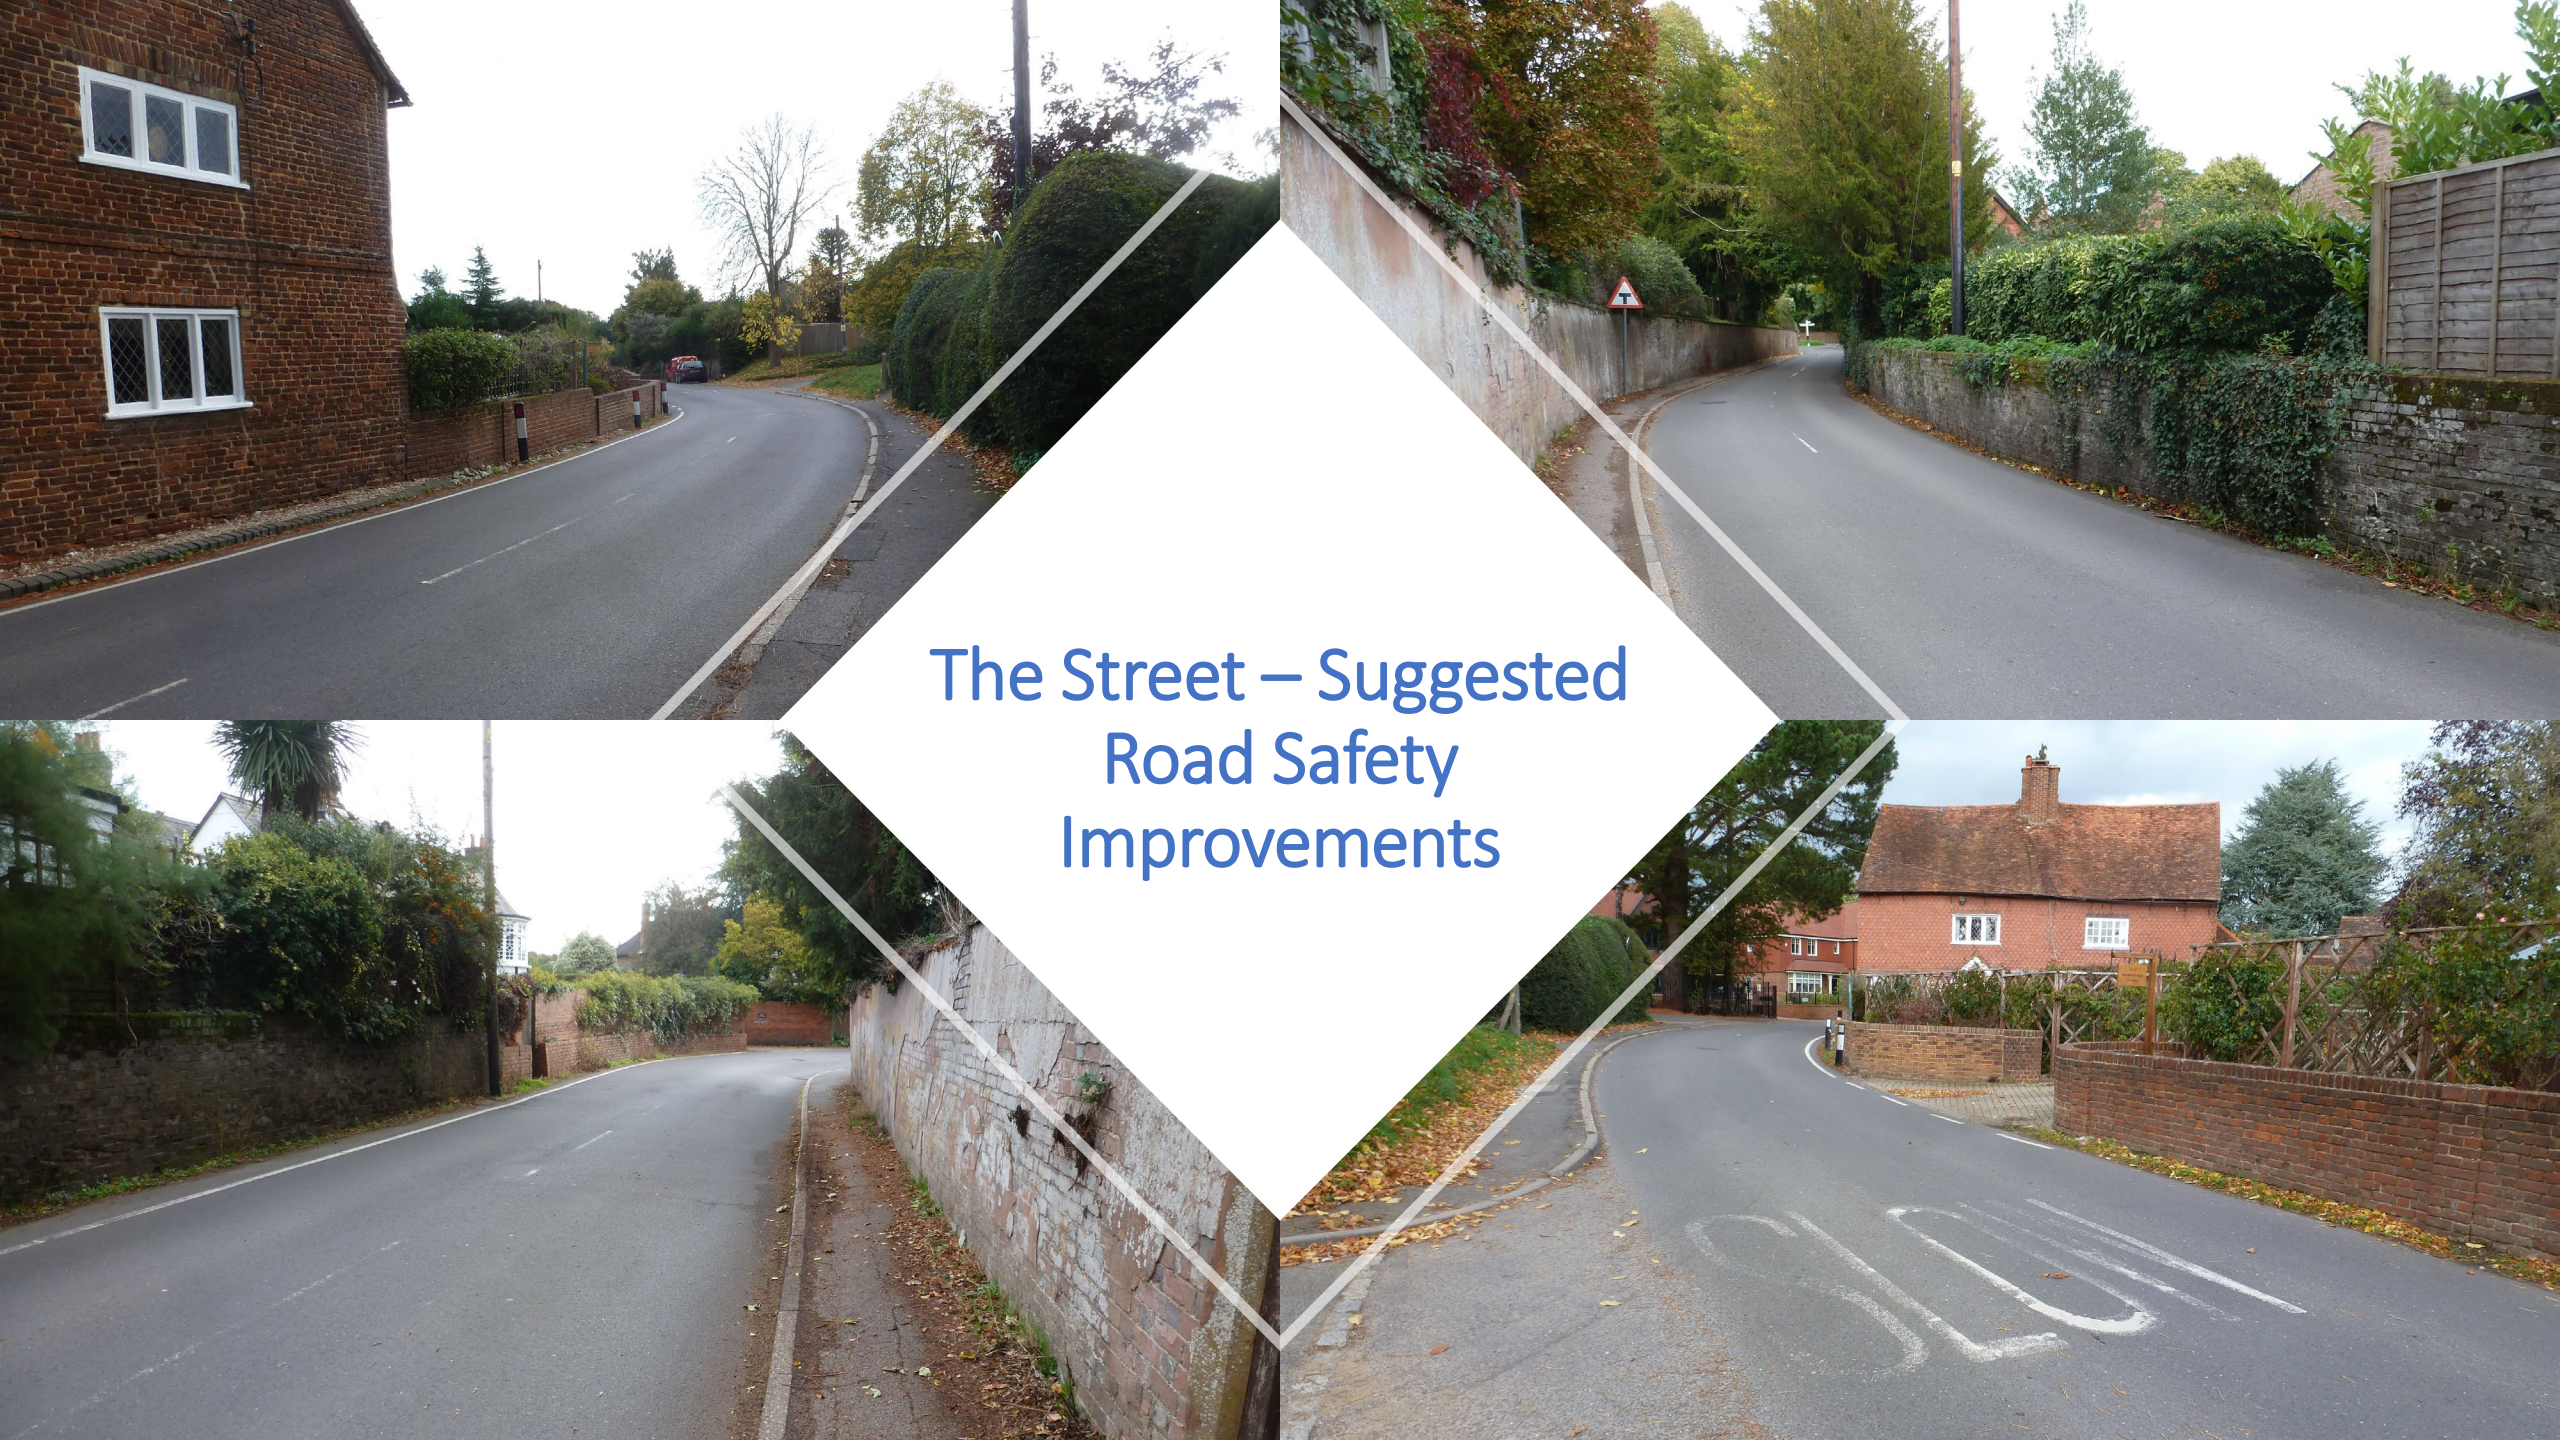
Continuous white lines,
broken at
junctions/properties,
to be painted on both
kerb and boundary
sides

'SLOW' sign to be
repainted in road here

Centre lines erased – to be
repainted with broken white
lines

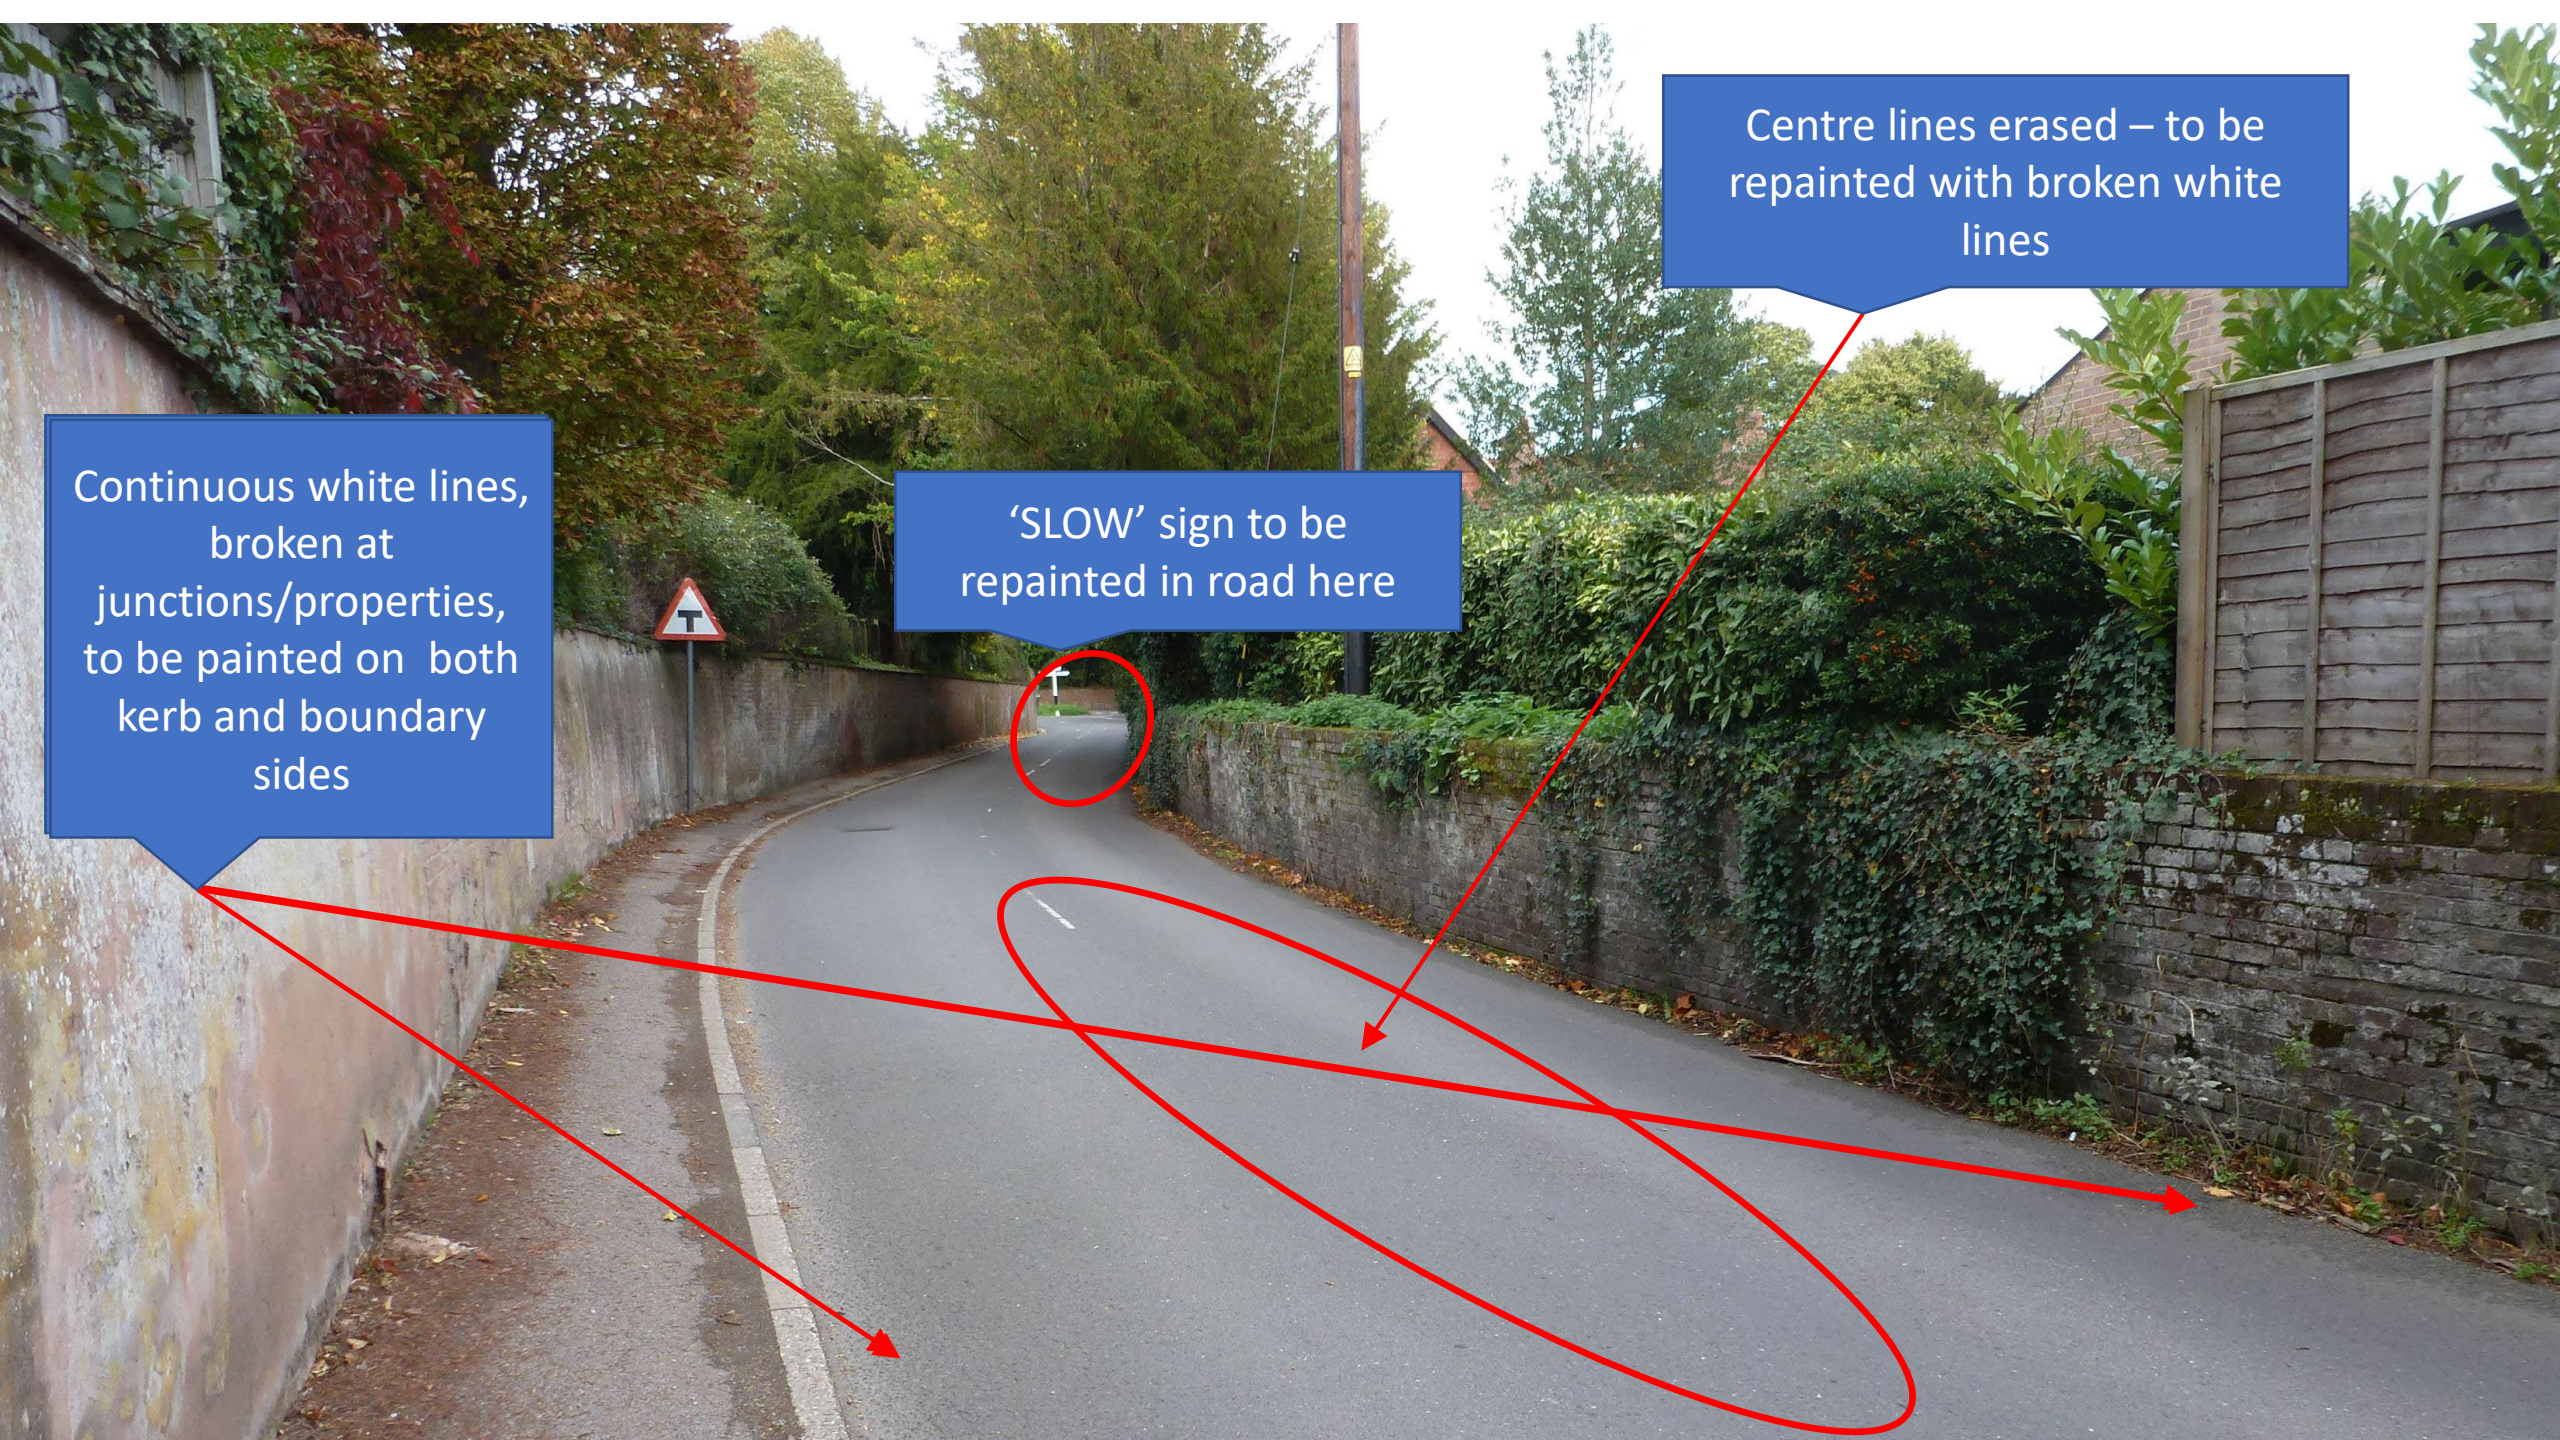
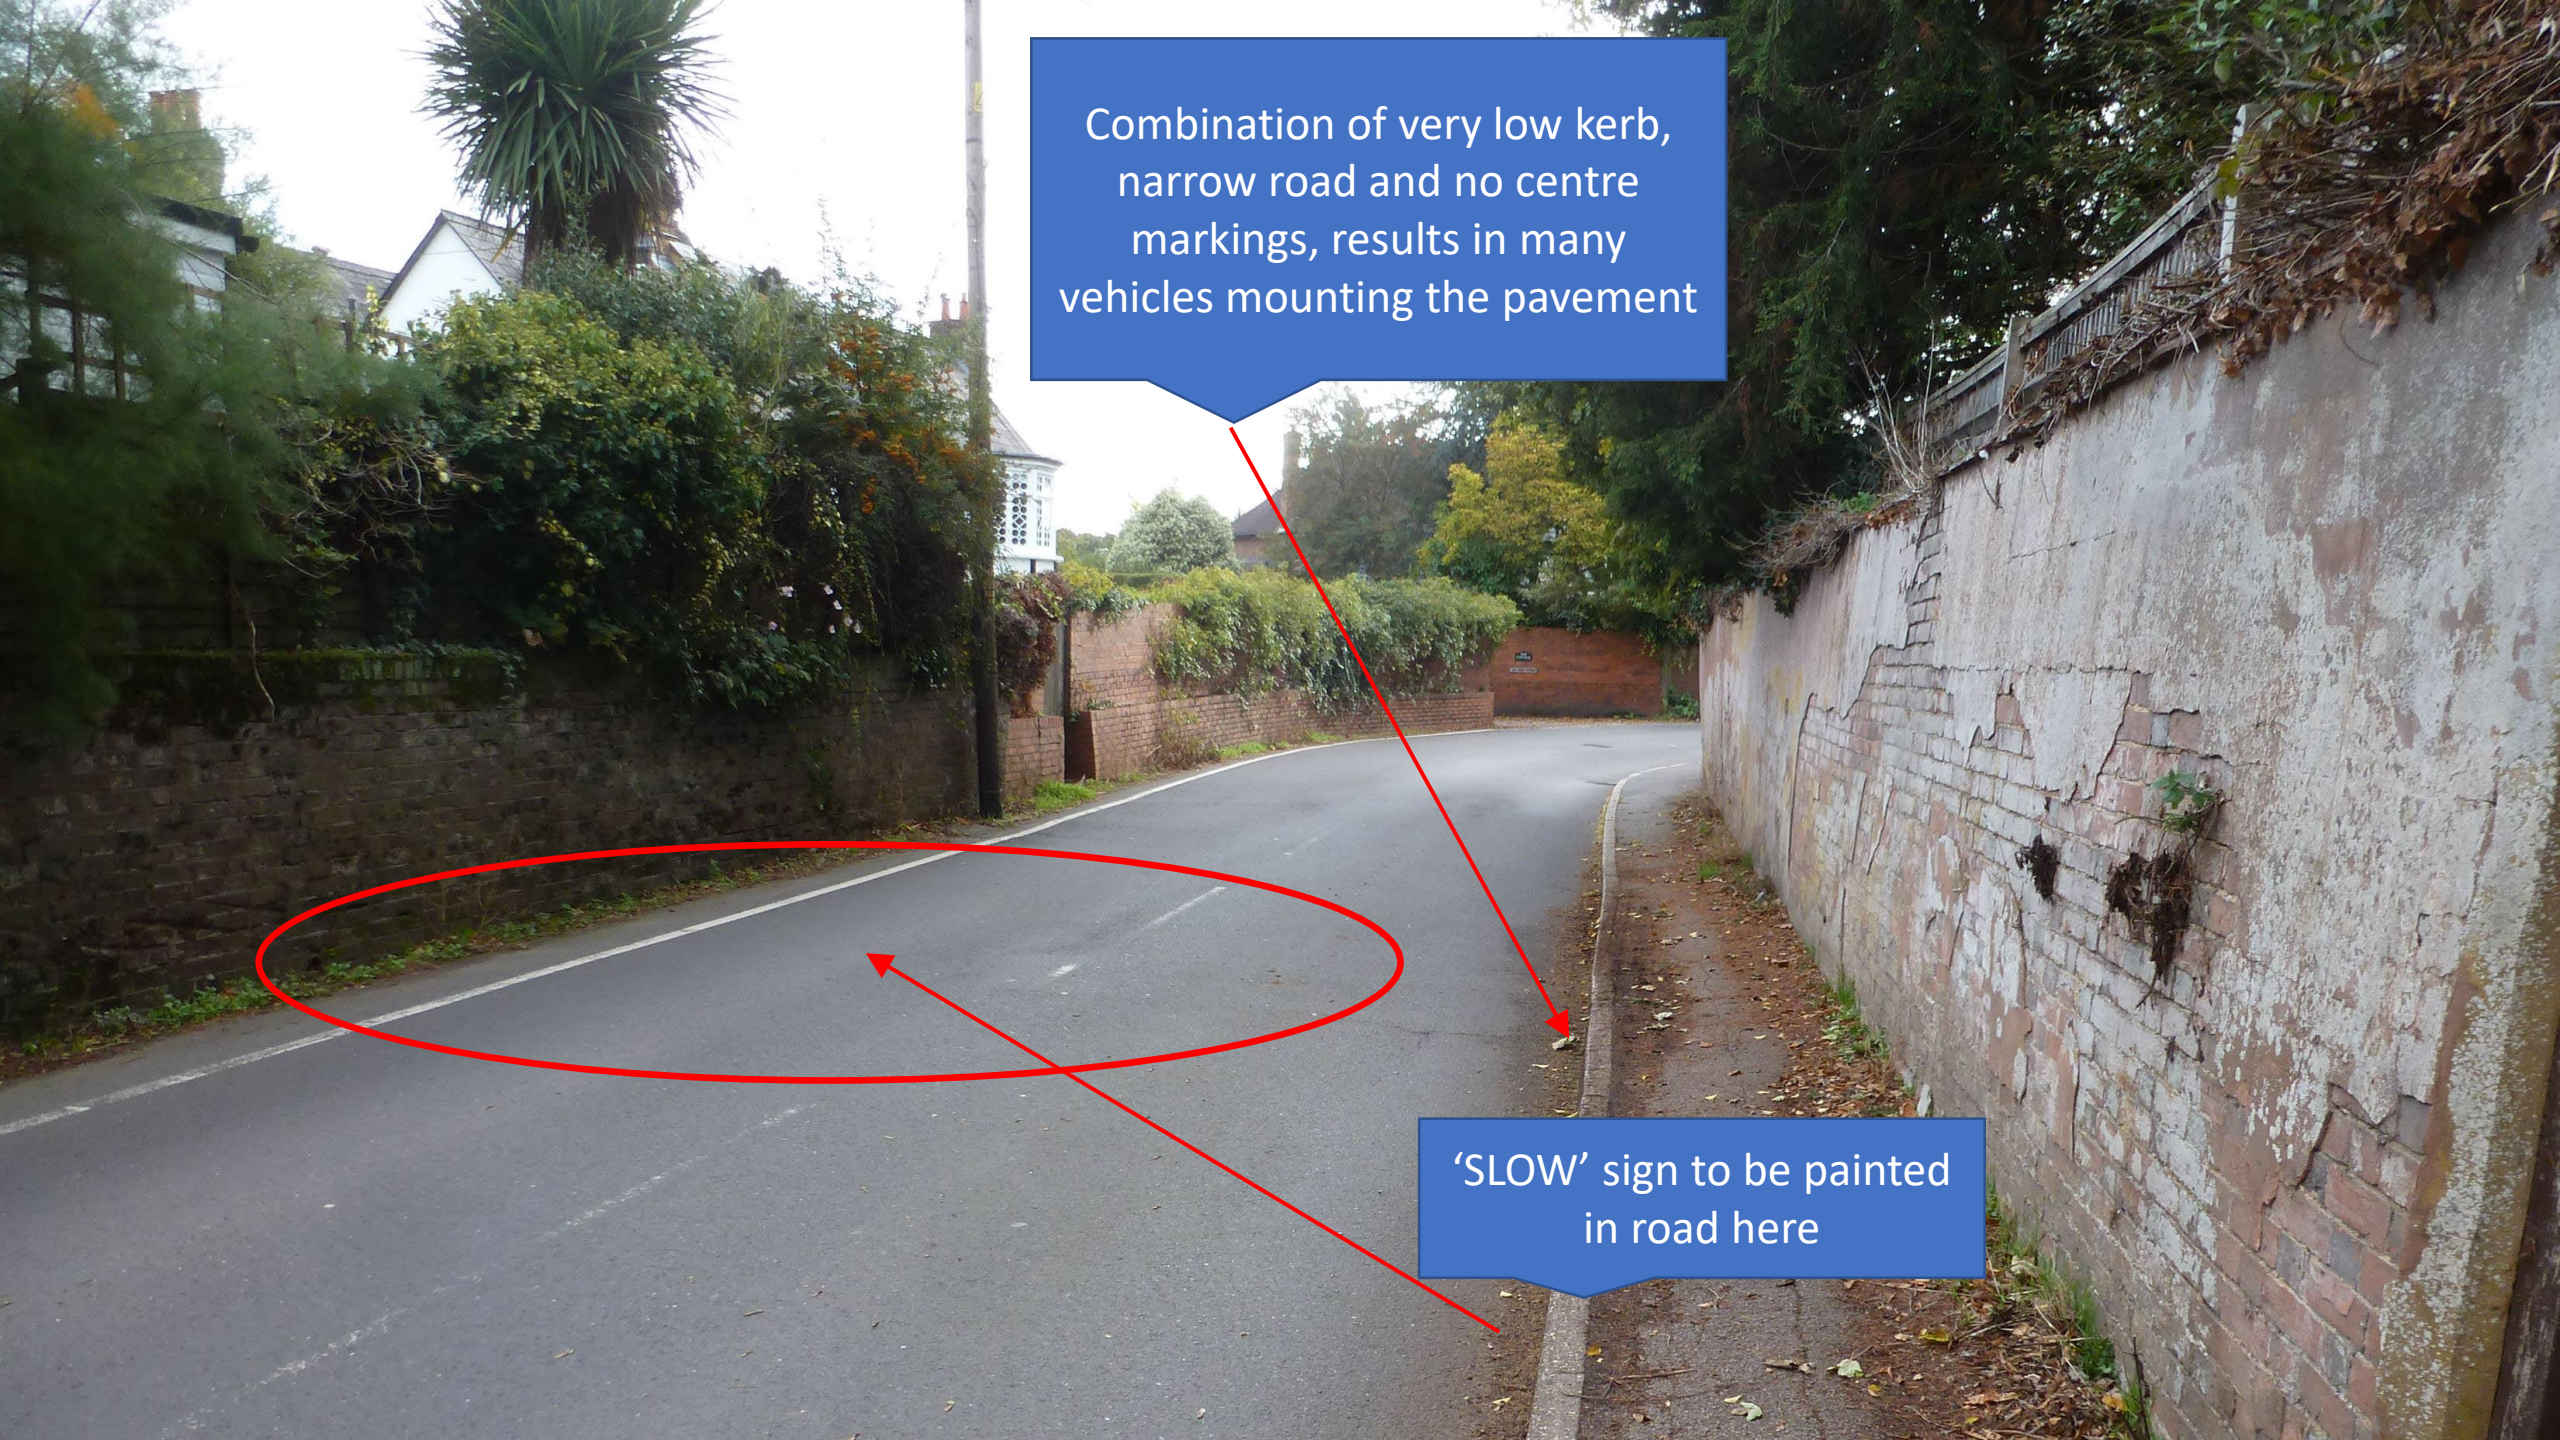
Combination of very low kerb,
narrow road and no centre
markings, results in many
vehicles mounting the pavement

Combination of very low kerb,
narrow road and no centre
markings results in many vehicles
mounting the pavement

'SLOW' sign to be painted
in road here

Continuous white lines,
broken at
junctions/properties to
be painted on both
kerb and boundary
sides

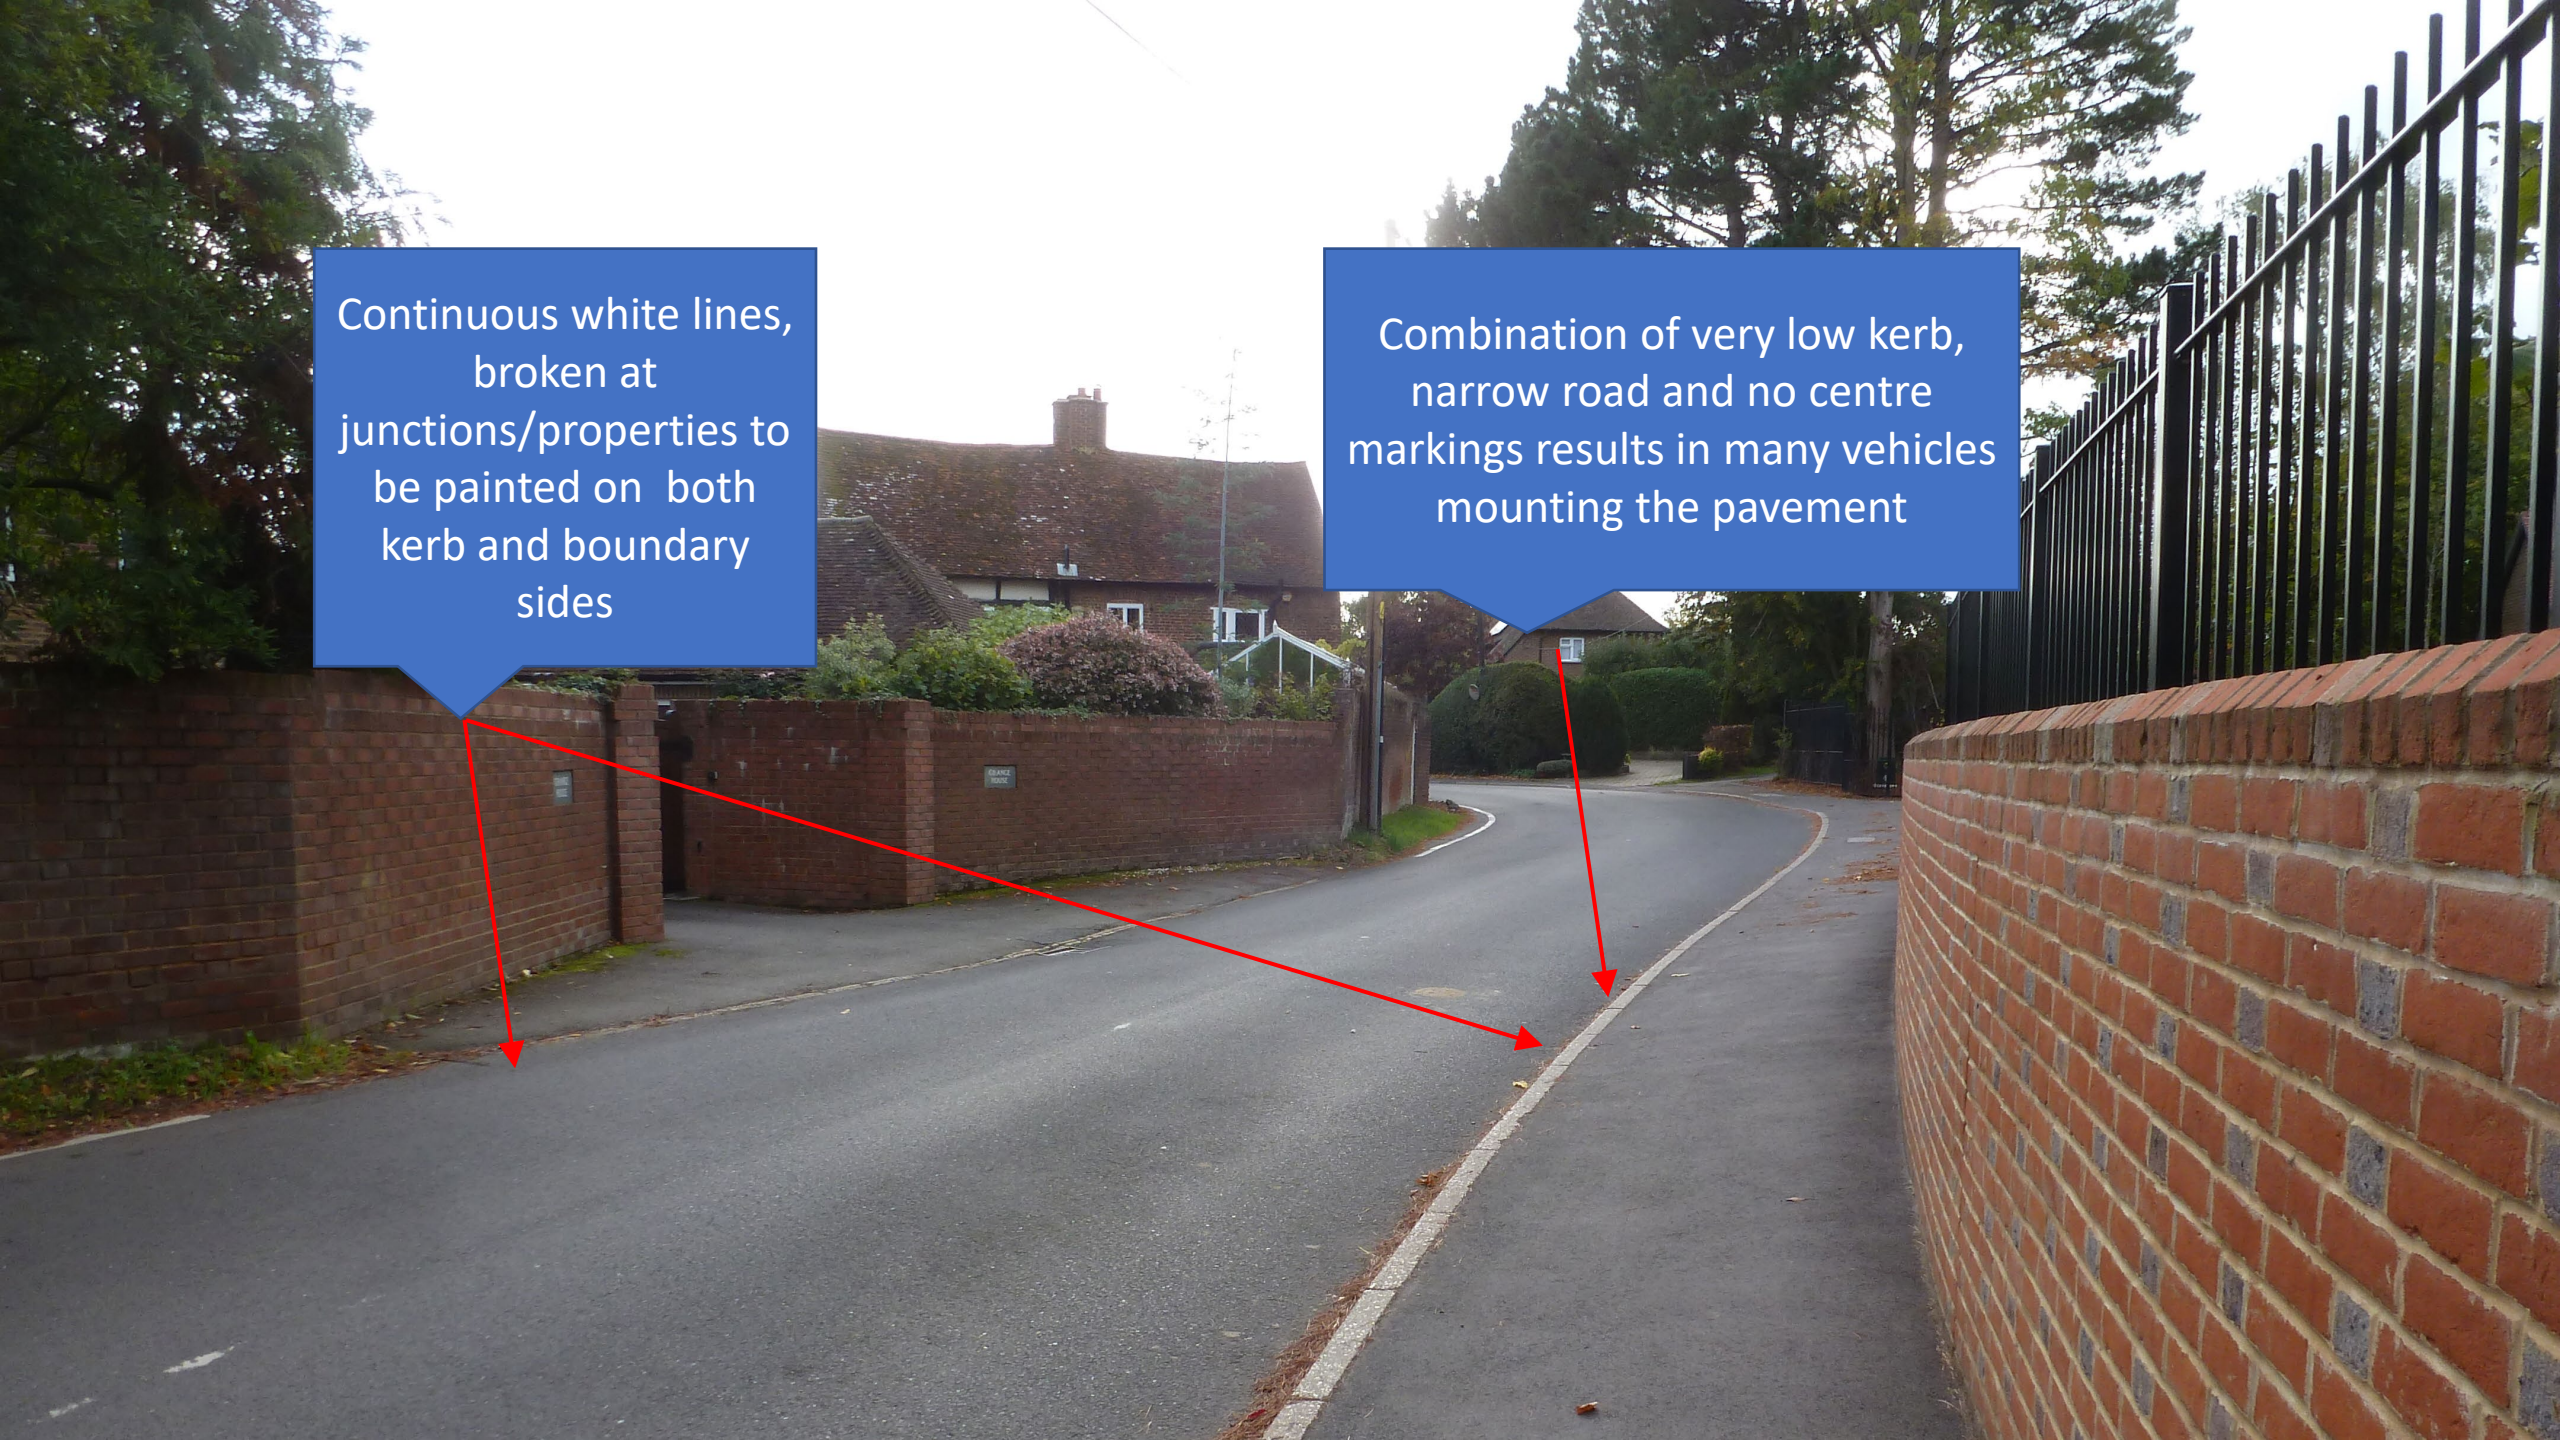
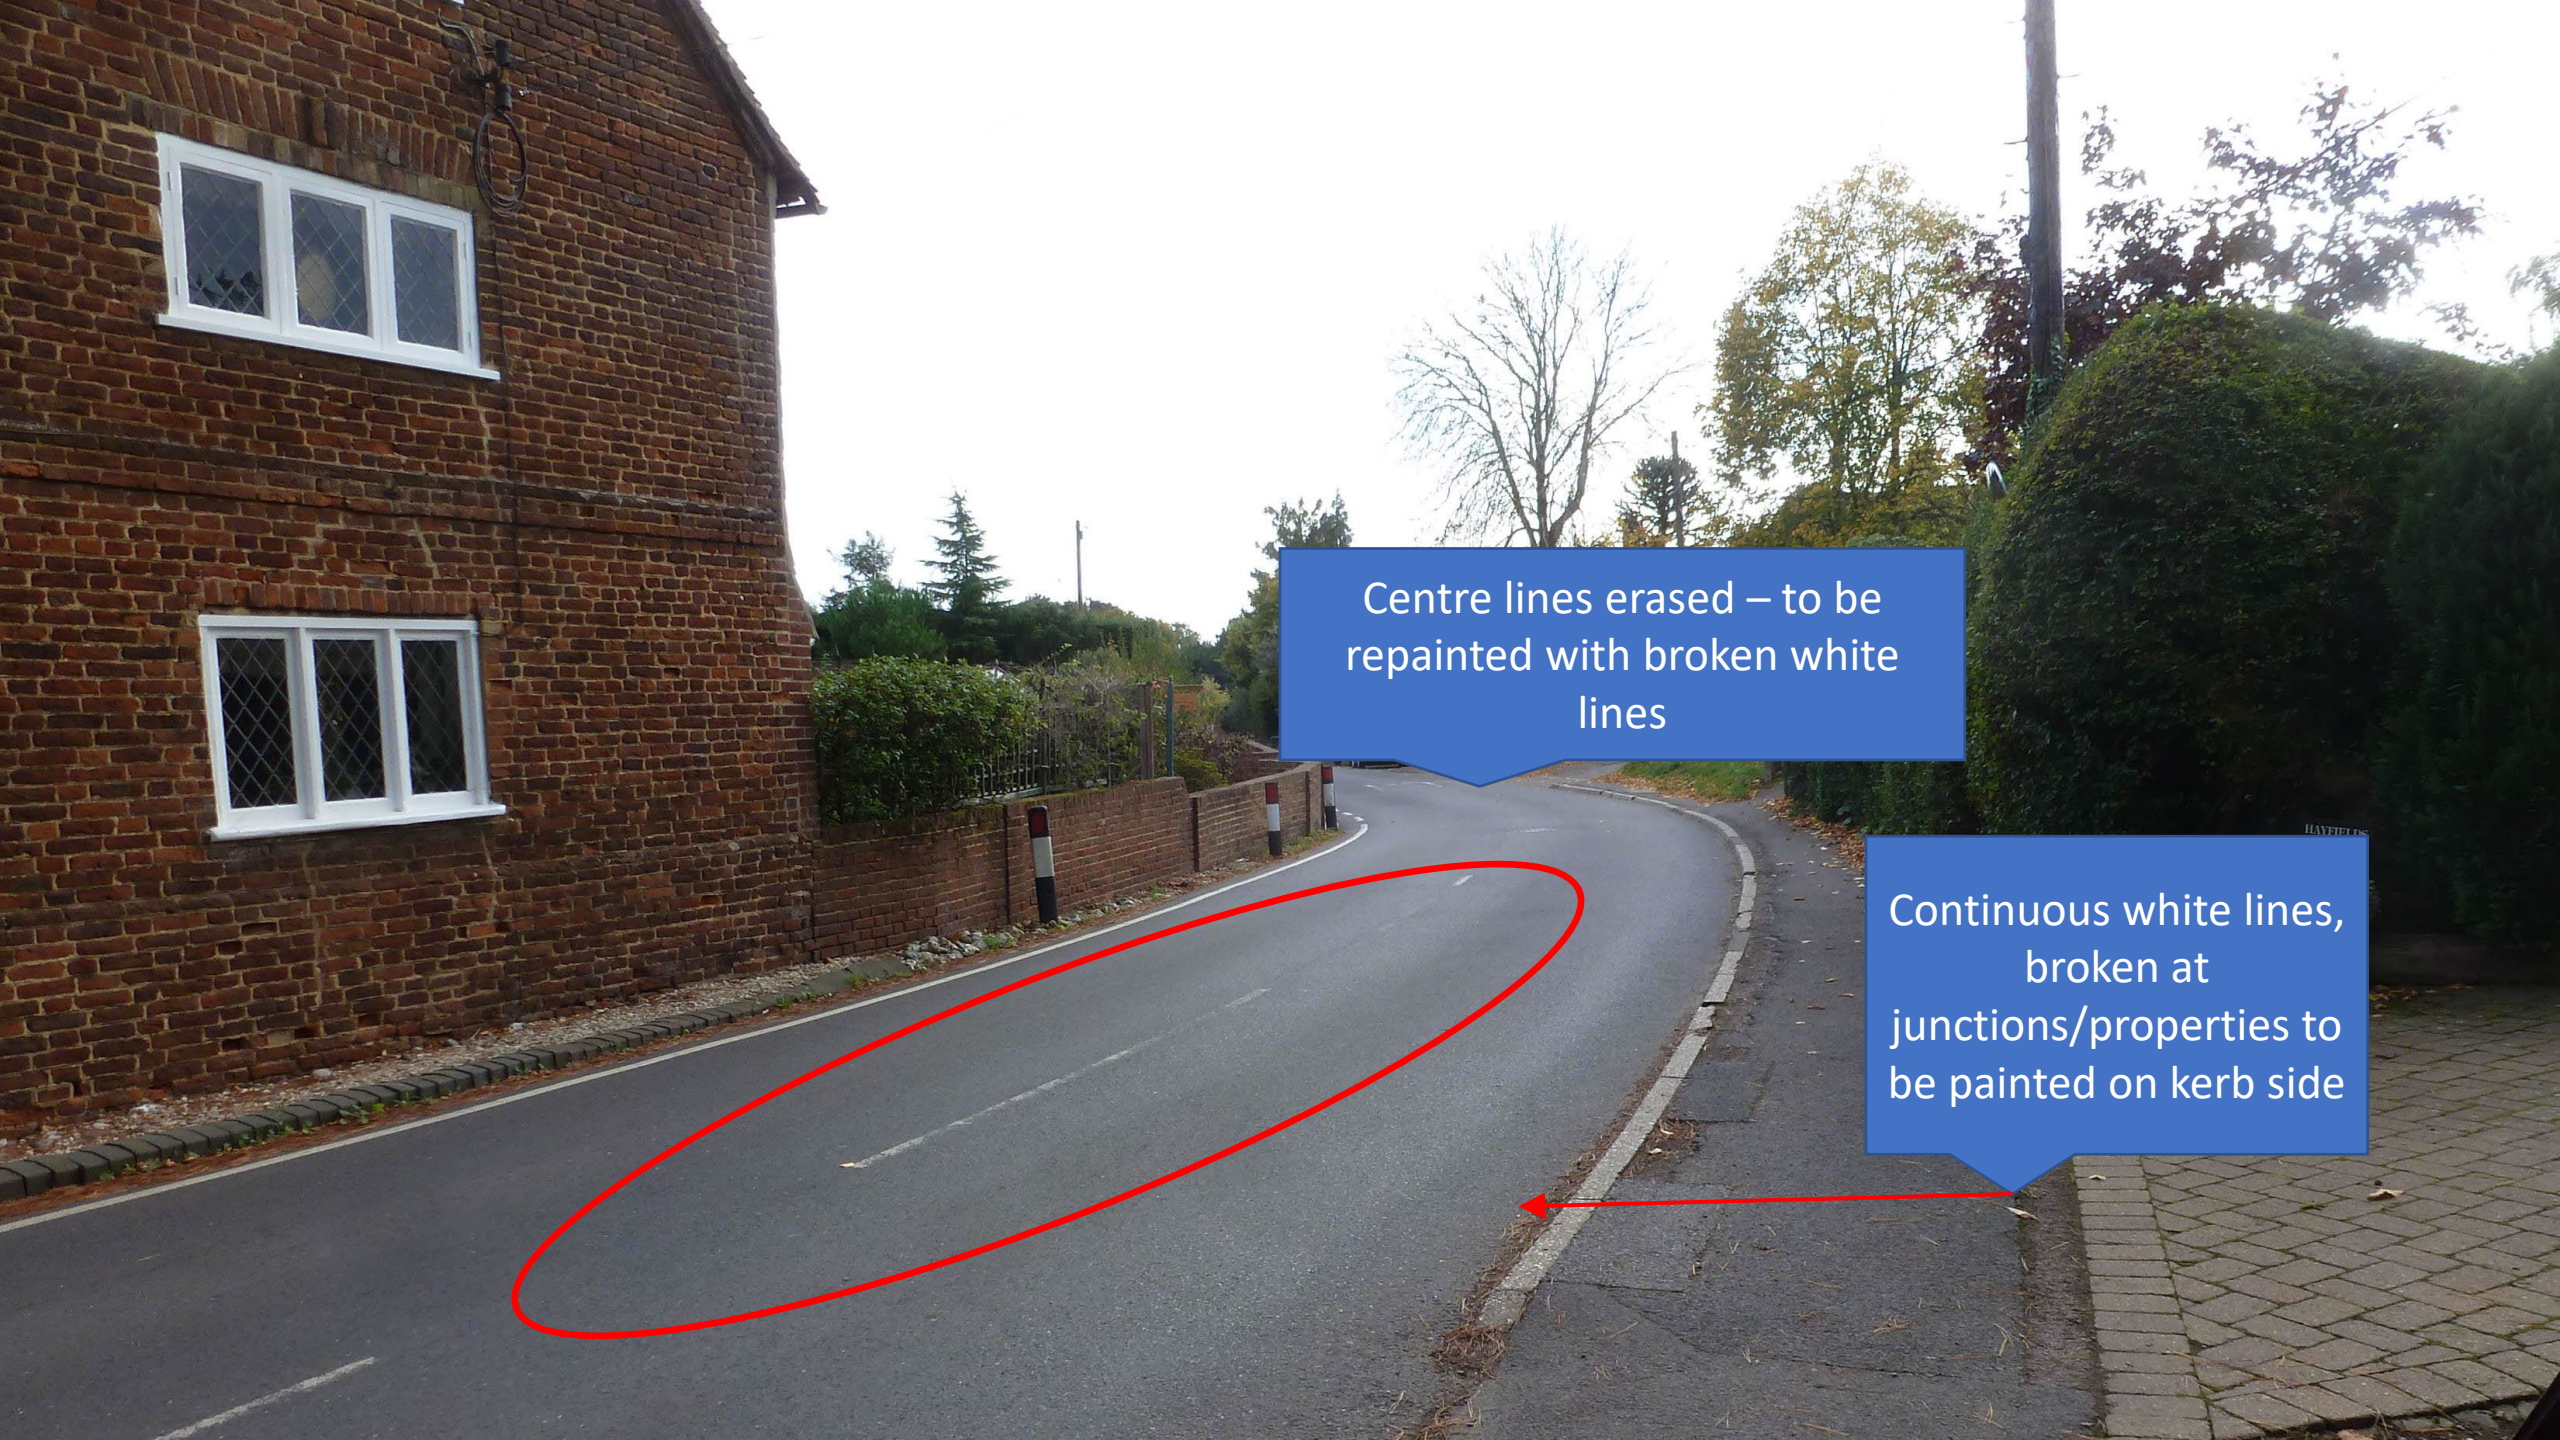
Centre lines erased – to be repainted with broken white lines

Continuous white lines, broken at junctions/properties to be painted on kerb side
